Manhole Inspection Summary

Manhole # S13II_034MH

Insp Date: **2/21/09 11:04 AM**

Location Address: **1376 ASHBURTON ST**

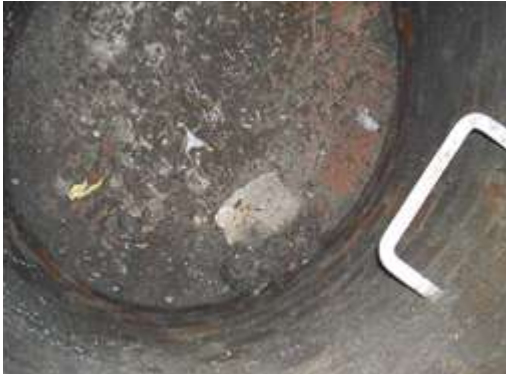
Defect 4

Condition: ☐ Sound ☐ Cracked ☐ Root Intrusion ☐ Deteriorated ☐ Leaks ☒ **Debris**

debris on channel

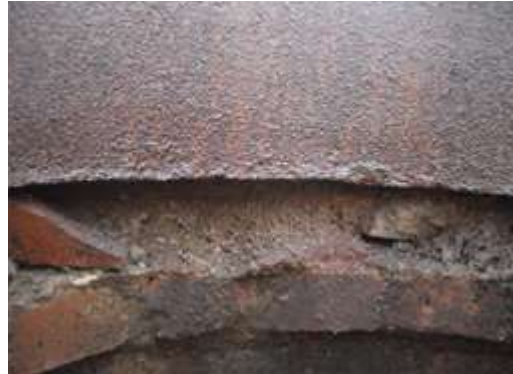
Defect 3

Frame Offset: **0** (in.) Condition: ☐ Sound ☒ **Cracked** ☐ Leaks

frame cracks between frame and corbel

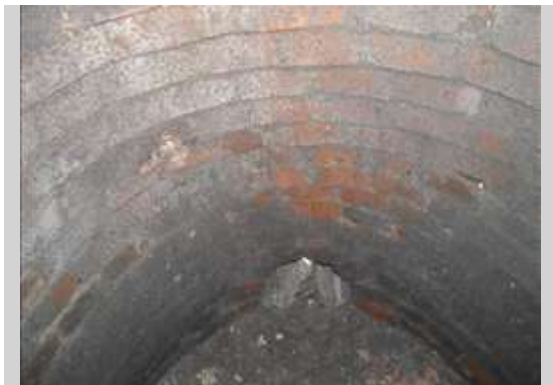
12 O'Clock Outflow

10 in. Circular Gravity Sewer
Pipe Out @ 12 O'Clock

Deposits: ☐ None ☐ Mud ☐ Sludge ☒ **Debris** ☐ Grease

Silt Depth: **1** (in.) Deposits Extent: **Light**
